Investigation of wheelchair ingress/egress activities in large accessible transit vehicles and evaluation of ADA ramp guidelines for improved ramp safety and usability.

A Thesis
Submitted to the Faculty of the
University of Louisville
J.B. Speed School of Engineering
in Partial Fulfillment of the Requirements
for the Professional Degree

Department of Mechanical Engineering

April 2009

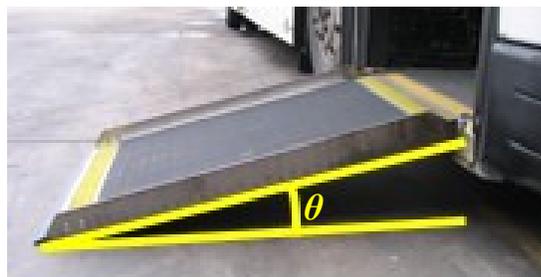
FIGURE 7 – Ramp Angle Associated With Ingress/Egress Events

According to the ADA ramp specifications, the maximum ramp angle allowed is 9 degrees (1:6 slope) when the ramp is kneeled onto a 6-inch curb/sidewalk, and 14 degrees

(1:4 slope) when the ramp is kneeled onto the street (see Figure 7 for angle reference). The control switch to kneel the LATV must be activated before the ramp can be extended, thus ramp deployment cannot occur unless the LATV is kneeled. However, the extent of the LATV kneel is determined by the LATV operator. The kneeling height of the LATV is important because the length of the ramp is fixed. Therefore, the kneel height of the LATV is the primary influence on the ramp slope – the longer the duration of the switch is depressed, the lower the LATV height, which results in smaller ramp angles during ascent/descent. LATV kneeling and ramp configurations used in all of the camera-system equipped TARC LATVs can achieve a ramp angle range between 7 to 17 degrees. Table VIII shows the range of angles associated with kneeled LATV position and level of ramp extension. For minimally kneeled LATV heights, the measured angles exceed the ADA specifications for both street and sidewalk levels. Thus, full LATV kneeling and ramp extension onto sidewalk levels are critical in assuring ramp angles during ascent/descent that comply with ADA guidelines.

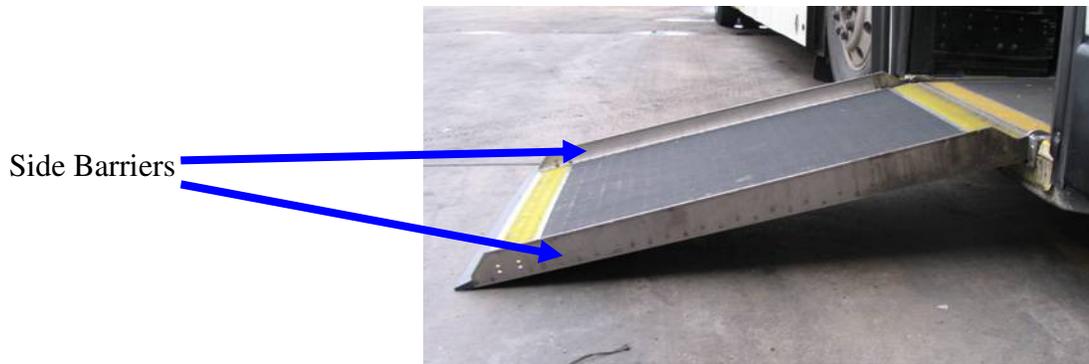
FIGURE 8 – TARC LATV Ramp Side Barriers

The main purpose of side barriers is to prevent wheelchairs from falling from the ramp. The ADA guidelines specify a side barrier height of 2 inches as measured from the surface of the ramp. TARC LATV side barriers as shown in Figure 8 are 2 inches in height from the ramp surface to the top of the barriers, and thus meet ADA guidelines. In this study, ramp side barriers performed sufficiently in containing the wheelchair within the ramp area in all events except during one egress incident. This incident involved a power wheelchair user who drove his/her front right wheelchair caster over the right side barrier during egress. The LATV operator assisted in placing the caster back onto the ramp and guided the wheelchair and wheelchair passenger down the ramp. With the improvements in wheelchair maneuverability and power output (especially in power wheelchairs), a raised barrier may be necessary to prevent future incidents (LaPlante, 2003).

Lastly, the height of the side barriers in relation to power wheelchair and scooter propulsion should be further investigated. The power required to overcome obstacles such as side barriers is proportional to weight of the wheelchair, wheelchair user, and personal items. Based on the only incident that occurred in this study, the side barriers failed to contain the wheelchair within the ramp surface area. An increase in the height of the side barriers may have prevented the wheelchair and/or any wheelchair components from traversing over the ramp side barrier.

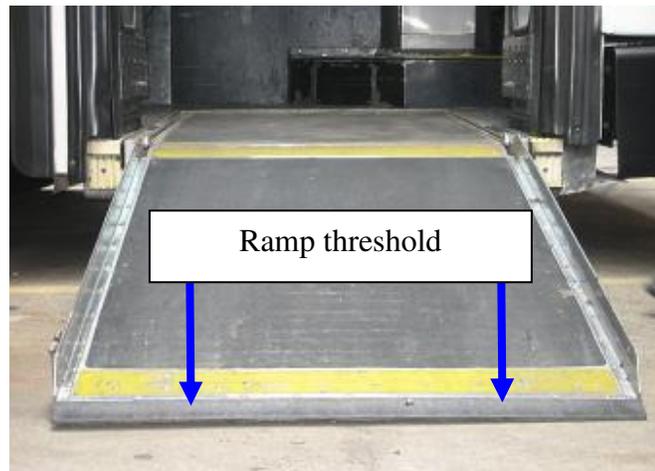
Figure 9 – TARC LATV Ramp Threshold

Ramp thresholds on TARC LATVs are beveled with a rubber wedge and meet the ADA specifications of a slope of 1:2 as shown in Figure 9. However, when the ramp is extended onto uneven terrain surface, the ramp may not be completely flush with the surface. This may be a result of uneven surface terrain or degradation of rubber material. Regardless of the underlying cause, vertical gaps between the outer terrain surface and the ramp surface may result in ramp deformation from wear and tear. In this study, the wheelchair passenger experienced minor bumps and stops when the wheelchair initiated contact with the ramp.

designed for loads up to 600 lbs. Several TARC LATV ramps showed deformation when the ramp was extended, which was evident by uneven vertical gaps between the ramp threshold and the terrain surface. During video analysis, we also observed both ambulatory passengers and a wheelchair passenger occupying the ramp at the same time. With the increase in heavier wheelchairs and common occurrences of ambulatory passengers occupying the ramp simultaneously with wheelchair passengers, current ramp design specifications may not be sufficient and must be reconsidered for higher ramp loads.

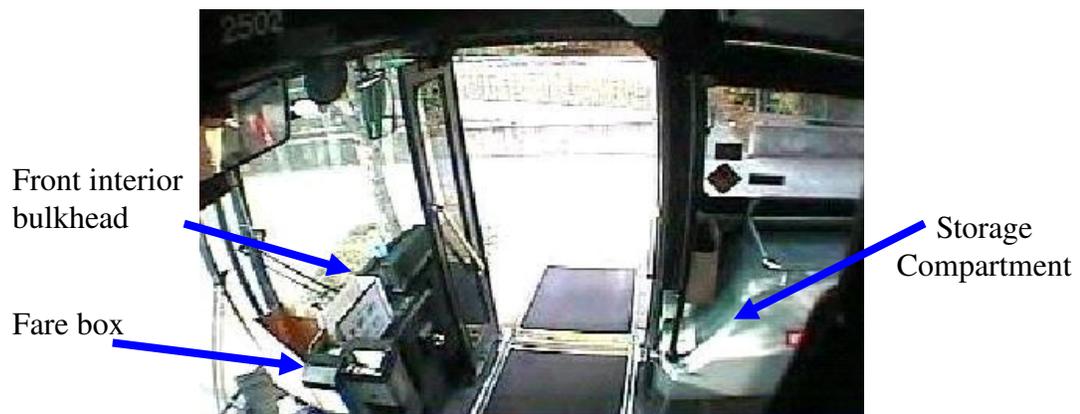
FIGURE 10 – Interior TARC LATV Components in Access Path

shown in Figure 10. Integration of the fare box into the LATV front interior dashboard will eliminate the surface footprint of the fare box post which may reduce occurrences of LATV obstruction. Furthermore, reduction of front storage compartments to accommodate larger access path widths may also decrease wheelchair passenger difficulty and/or incident. Current ADA requirements only address surface widths in terms of allowable floor space for wheelchair passengers and are based on common wheelchair widths. Additional research is needed to accommodate not only large wheelchairs, but also allowable space required above the floor surface for bags and other personal items attached on the wheelchair.

Additionally, TARC LATVs are equipped with mounted interior lights that protrude into both sides of the aisle and are adjacent to the LATV door. These mounted lights protrude approximately 18 inches above the LATV floor. Although the review of video data was unable to conclusively determine whether or not these interior lights obstructed passengers observed in this study, these lights may be an additional source of LATV component obstruction. Replacing these interior light fixtures with LED floor strips may provide more room for wheelchair passengers to maneuver.

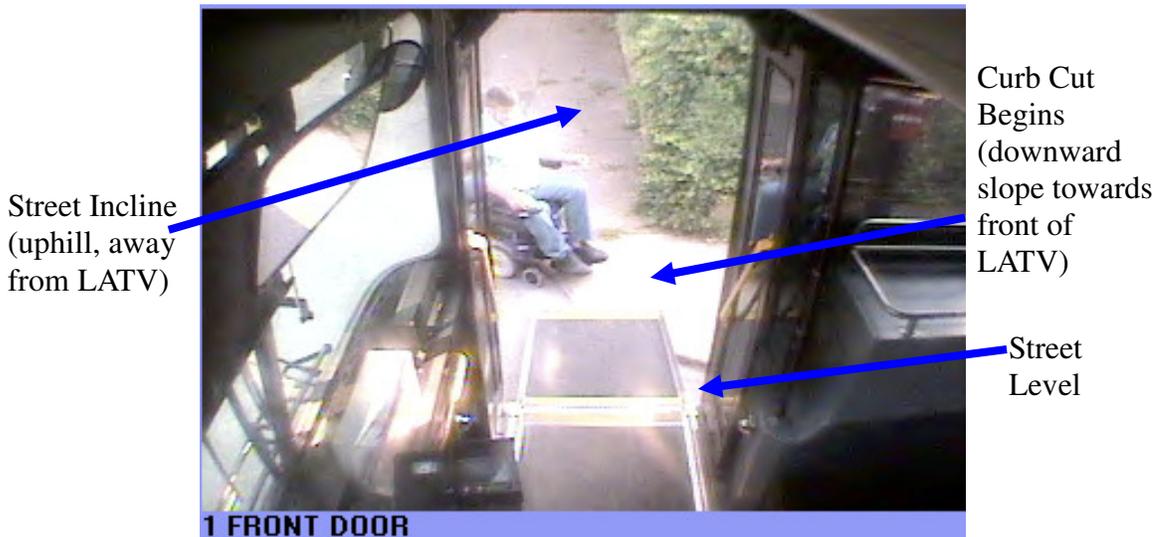
FIGURE 11 – Example of ramp deployment onto uneven surfaces

LATV operator factors contributing to adverse events involved ramp extension onto uneven surfaces (i.e. deploying the ramp across a curb cut and sidewalk) and ramp extension near sidewalk curbs (when ramp is deployed onto street). Figure 11 shows an example of the ramp being halfway extended onto the street and the other half onto curb

cut. In this study, ramp deployment onto uneven terrain and/or inadequate clearance beyond the ramp contributed in 5 of 22 adverse ingress events (see Appendix II). These factors may contribute to frustration for wheelchair passengers who have to perform multiple back and forth maneuvers to overcome the uneven terrain or limited clearance. Consequently, these factors may also increase ingress time, which may delay the fixed-route schedule to which LATV operators must adhere to for other passengers who rely on their services. There were no ramp extension issues that contributed to adverse egress events. Additional LATV operator training is recommended to ensure the ramp is deployed with sufficient clearance for wheelchair passenger ingress/egress. In addition, public obstructions such as bike racks, LATV stop shelters, fire hydrants, and trashcans should be avoided.
