### Effect of slope and paver characteristics on performance of permeable pavement GI.

EFFECT OF SLOPE AND PAVER CHARACTERISTICS ON PERFORMANCE OF  
PERMEABLE PAVEMENT GI

A Dissertation

Department of Civil and Environmental Engineering

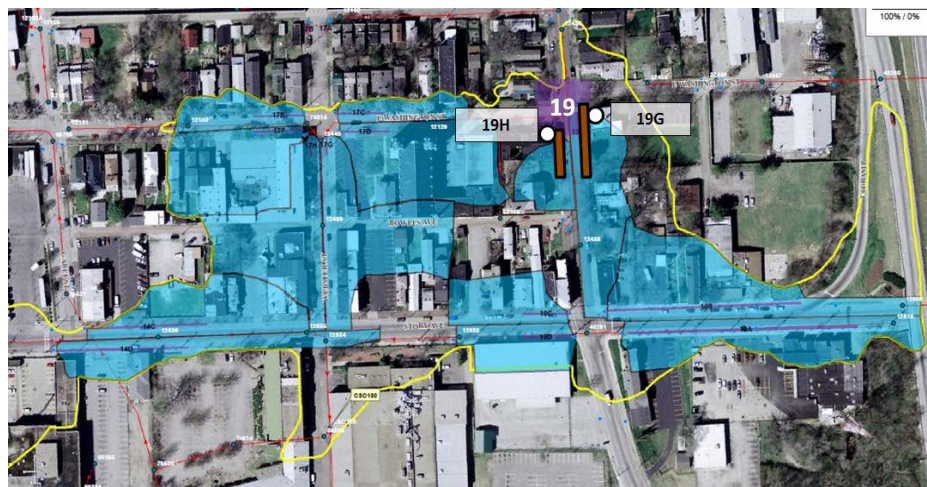
Figure 2: CSO130 area

Within CSO 130 a series of green infrastructure practices were devised to infiltrate, retain and exfiltrate stormwater runoff during and after rain. The first phase of the GI installations consisted of two strips of permeable pavement, identified as 19 G and 19 H on Figure 2. These GI were designed to accommodate the runoff associated with the 9<sup>th</sup> largest downpours of a typical year. In general, each GI is composed of a 60 cm deep storage gallery and a 3 m deep trench, as shown in Figure 3. The length of the trench is based on the quantity of flow from its tributary area. Table 1 provides more details on the dimensions of 19 G and 19 H.

CSOs. As it was explained in the Introduction, the first phase of the project consists of installing permeable pavement systems within watershed CSO130. CSO 130, extending over 11.3 hectares, is located in the Butchertown neighborhood. When the project began, the area was experiencing an average of 16 overflows per year as a result of stormwater runoff.

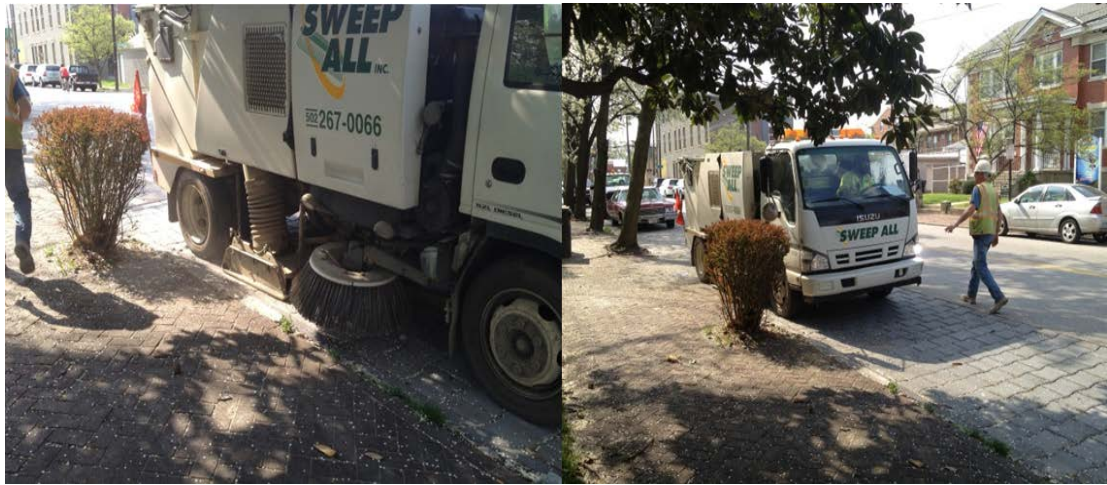
**Figure 4: Regenerative sweeper truck with NQR 435 vacuum chamber (53 hp)**

The pavement system maintenance methods evaluated included pressurized air blasts and a regenerative sweeper truck, ISUZU model NQR 435, as shown in Figure 4. The sweeper truck arrived with a clean and empty container. The sweeper truck covered a width of 330 cm using gutter brooms. The truck’s first run over the permeable pavement system was from the down gradient towards the up gradient, covering the whole width of the pavers and using only the vacuum chambers. The direction of sweeping was chosen

after considering the water flow (towards the GI) and with the aim of limiting debris movement on the GI. After a visual inspection, the process was repeated using both brushes as well as the vacuum chamber. The entire content of the container was collected as a single sample.

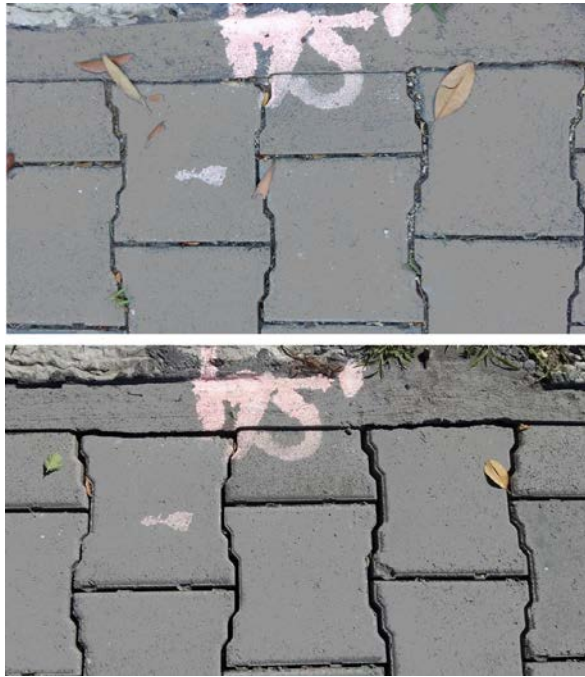
Figure 5: Visuals of practice 19 G before (above) and after (below) the maintenance

During the second round of maintenance for both permeable pavement systems, the effectiveness of pressurized air blasts for pavement cleaning was assessed. The objective of the pressurized air blasts was to blow out the debris from the paver gaps, working from the down gradient towards the gradient. To more accurately capture the spatial variation associated with the clogging debris, each practice was divided into smaller segments, as shown in Figure 6, and was cleaned independently. The debris that was extracted from each segment was swept to one corner and collected using a dry vacuum. The material recovered from each segment was collected as a separate sample; resulting in four samples for the longer practice and in two for the smaller one. Figure 5 is an image of the 19 G surface before and after using the air blast tool for maintenance.

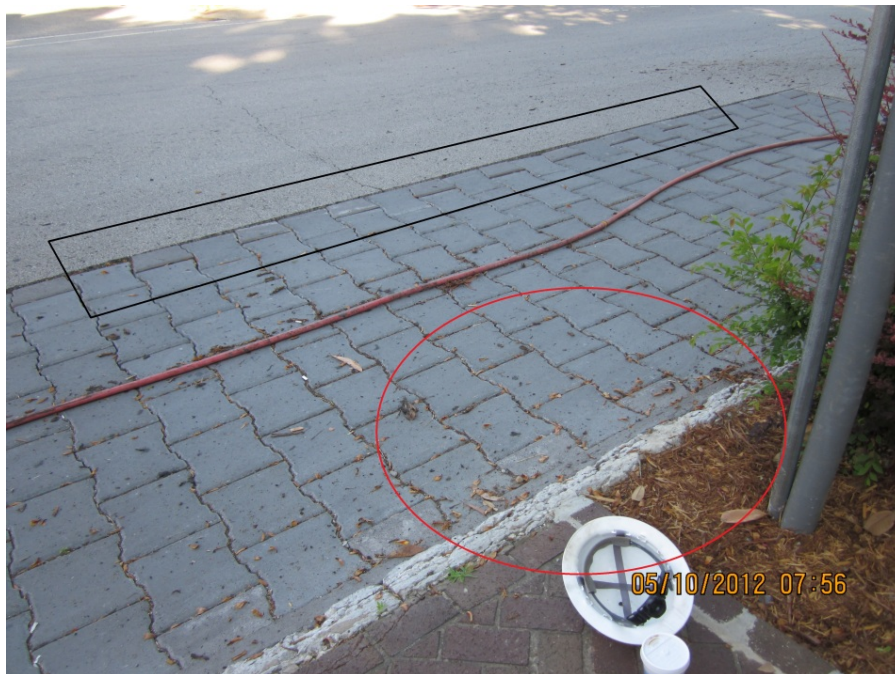
Figure 11: Segment A, 19 G, second maintenance

Within the service period of 19 G, the down gradient of the permeable pavement is mostly covered with organics which do not affect the performance of the permeable pavements as significantly as do the fine particles. The segments located adjacent to planting on the sidewalk on 19 G have caused mulch to migrate towards the surface

(Figure 10). Settlement in the structure of the pavement has also created an uneven surface that traps leaves and other organics. Results of similar studies have shown that the highest concentration of organic material recovered from a permeable pavement systems is located in the down gradient segments (Welker et al., 2012). The velocity of water running over the permeable pavement and carrying less dense particles towards down gradient segments may explain the concentration of organics at this location. Studies have also shown that the presence of a sidewalk will have a significant effect on the amount of sediment accumulated on the pavement (Viklander, 1998). The geometry of the sidewalk and height of the curb, as well as boundaries around the planting on the sidewalk can minimize the migration of sediment to the permeable pavement systems.

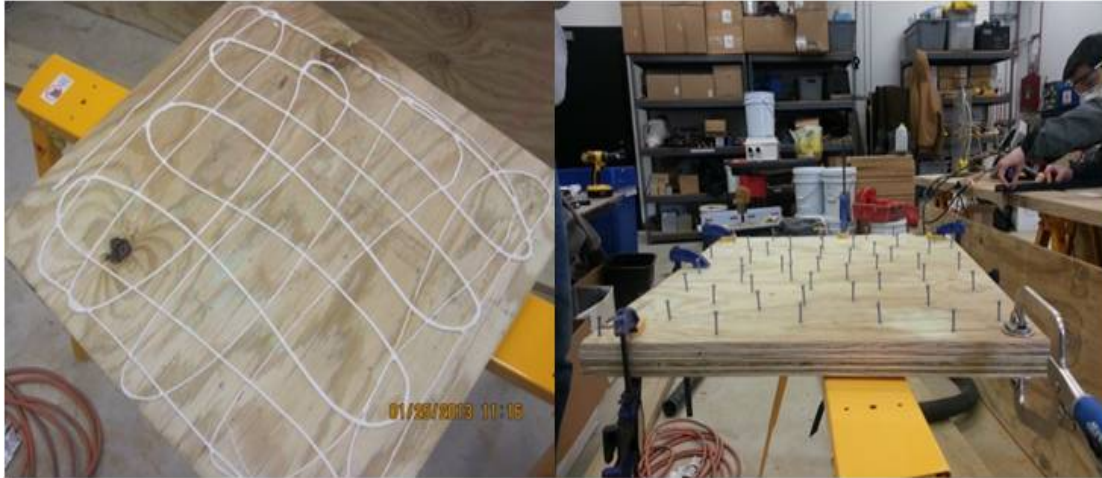
**Figure 12: Construction of the flume's panels**

With the considerations mentioned, the flume was constructed by attaching together two layers of pressure treated plywood. The maximum thickness of the available

plywood was 1.90 cm and therefore the flume was constructed using custom structure with the two layers of plywood glued and screwed together (Figure 12).

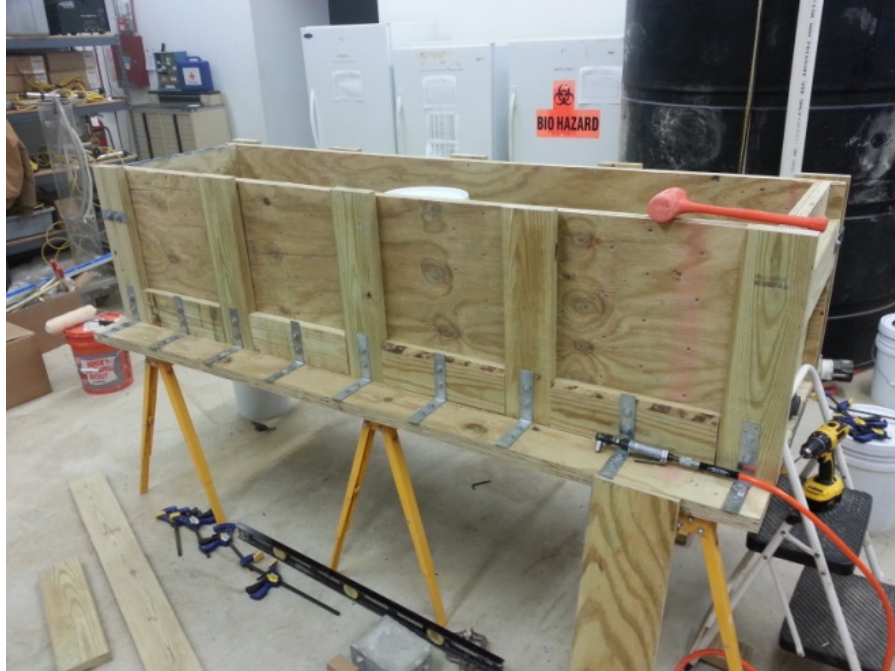
**Figure 13: Structure of the flume**

The walls were constructed with additional wooden beams and steel L brackets to support the lateral forces. The supports of the flume were also reinforced using additional wooden beams (Figure 13).

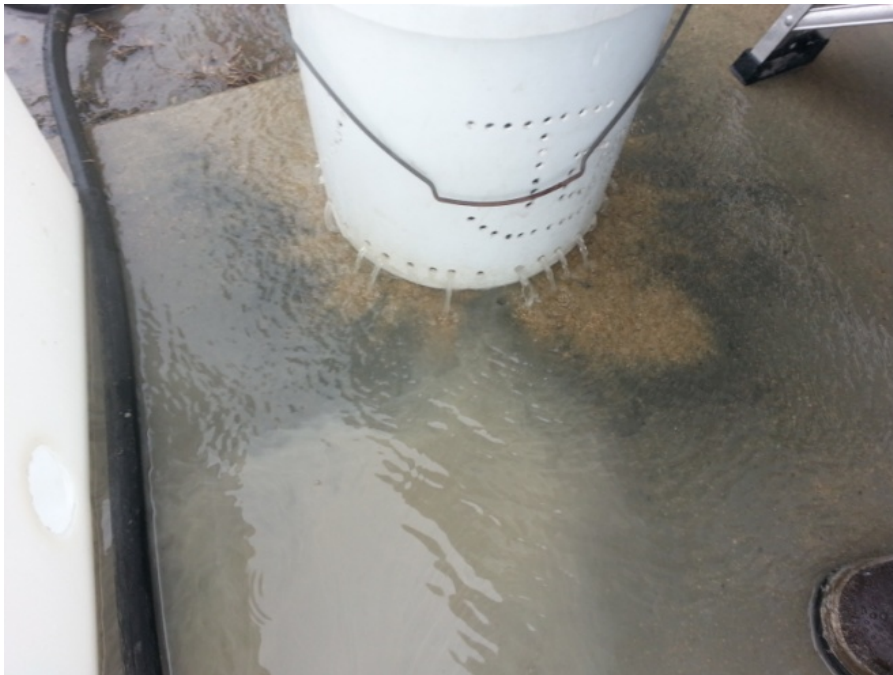
**Figure 16: Washing the aggregate using a pressure washer**

the project, it was determined that the “double washed aggregate” still carried about 3%-5% (by mass) attached solids. This number was determined from a series of attached solids tests on multiple samples taken from different truckloads of each type of aggregate delivered to the construction site. In order to minimize what effect the attached solids being washed off the aggregate would have on the clogging of the permeable pavement, all the stones used in the experiment were washed using a 3000 psi pressure washer (Rigid, 2013). They were washed in a perforated bucket until the water coming out of the perforations was visibly clear. Figure 16 illustrates the washing process.

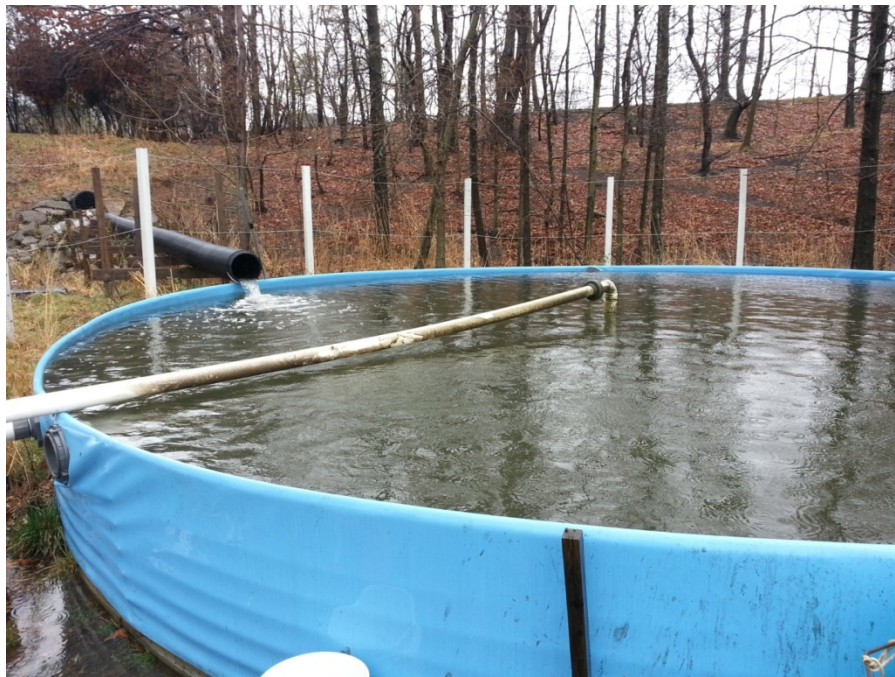
**Figure 17: Primary tank for collecting stormwater runoff**

The collected stormwater runoff in the primary tank, Figure 17, was expected to have an initial load of suspended solids. In order to monitor, understand and account for the effects on the experiment of the initial suspended solids in the stormwater runoff, after transferring the water to the test tank a 2 liter sample of the stormwater was collected and analyzed for total suspended solids (TSS).

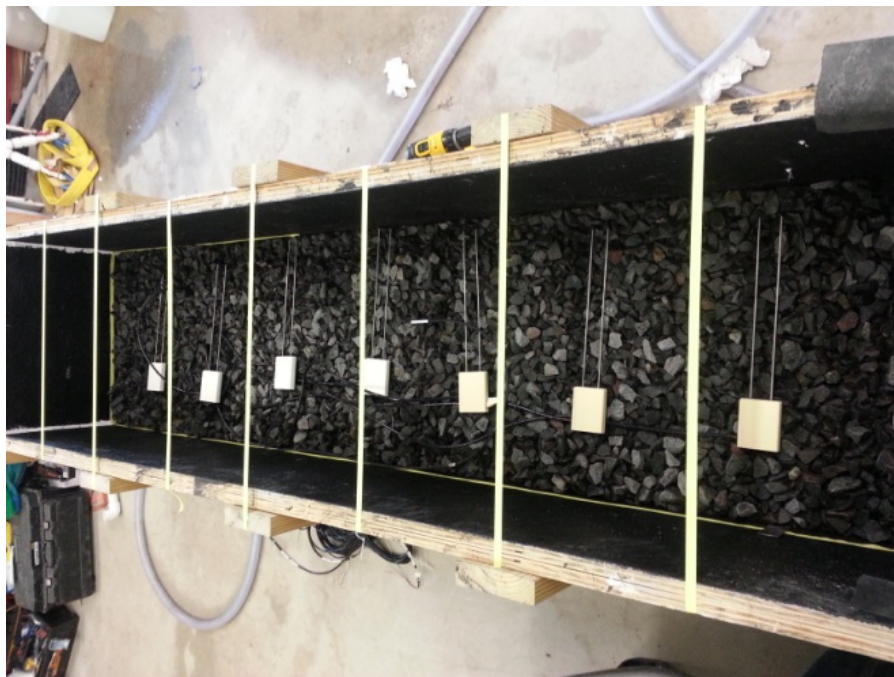
Performance of the flume in this study was measured using a TDR, (Campbell-Scientific, 2012). TDRs are used in the Adam's Street project in Louisville to measure the presence of moisture caused by running water in the storage gallery. As mentioned before, the use of TDRs in this experiment is not only a sound method, but would also help to verify the results of other studies that have looked at the application of time domain reflectometry and measuring VWC as an automated way of investigating the performance of GI and determining its maintenance needs. A total of 7 CS616 TDRs were located inside the storage gallery, 25.4 cm (10 inches) from the bottom. After the instruments were placed in the storage gallery, their communication wires were run through the effluent pipe and out of the flume. The TDRs were buried under another 10 cm (4 inches) of #57 aggregate and a 5 cm layer (2 inches) of #8 aggregate. Figure 21 shows the arrangement of the TDRs in the storage gallery of the flume.

**Figure 21: Arrangement of TDRs in the storage gallery**

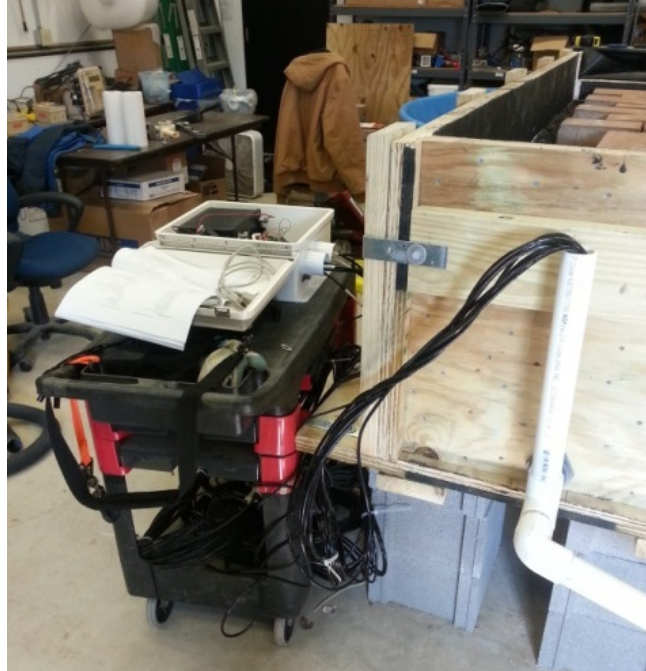
**Figure 22: Instruments wired to the data logger**

The data logger was programmed to read the measurements of the TDR every 10 seconds. The measurements were stored on the data logger and then downloaded into a computer after each experiment. Figure 22 shows the wiring of the instruments and the enclosure with the data logger.

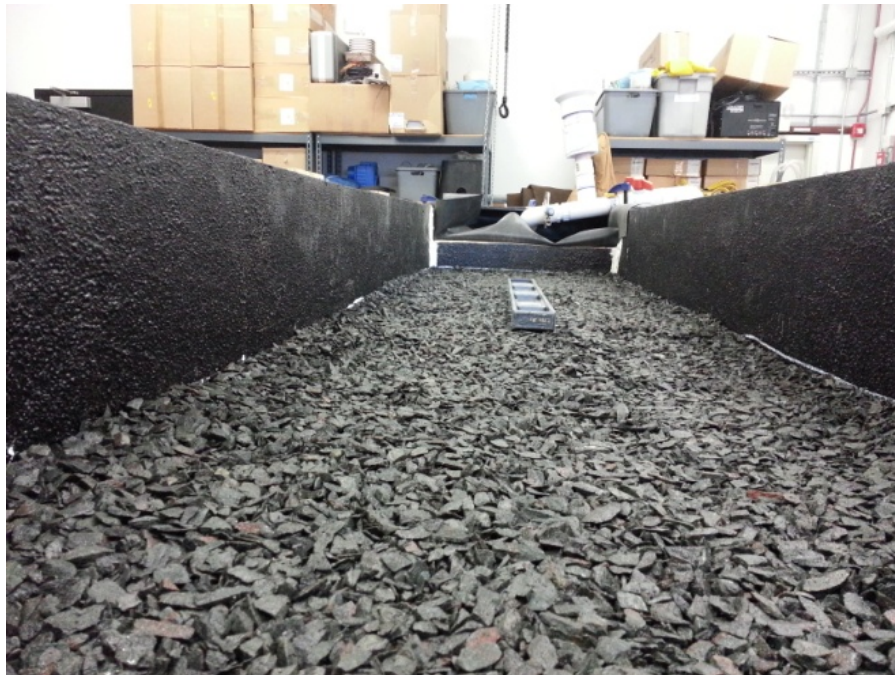
**Figure 24: Compacted and leveled bedding layer**

within practical laboratory limits, the top of the storage gallery was compacted by placing a wooden board on the aggregate and pounding it heavily. This method was also used to level the surface before placing the paver blocks in the flume.

Figure 24 is an image of the surface of the bedding layer after compacting and leveling the aggregate.

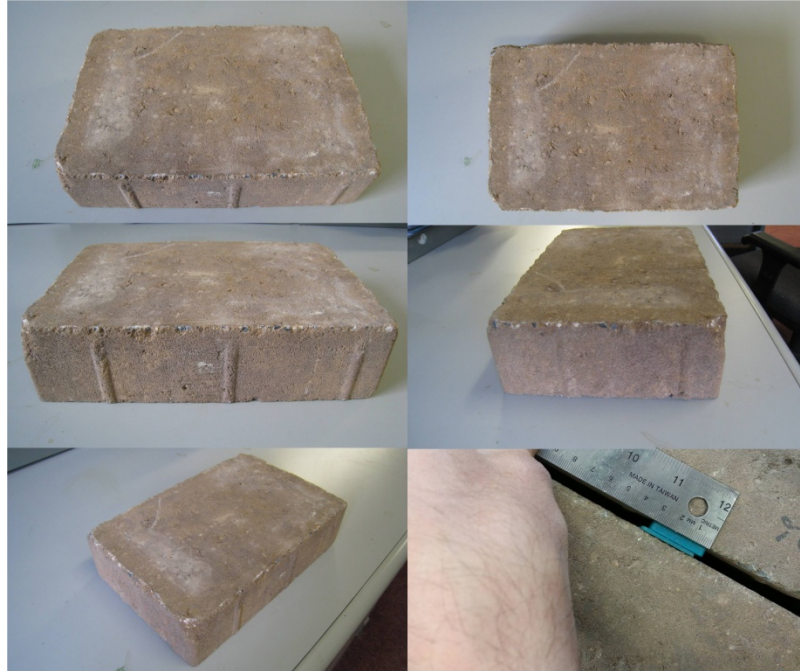
**Figure 25: Coventry I paver block**

Figure 25 shows Coventry I paver blocks, which provide 6 mm gap between the pavers using plastic spacers.

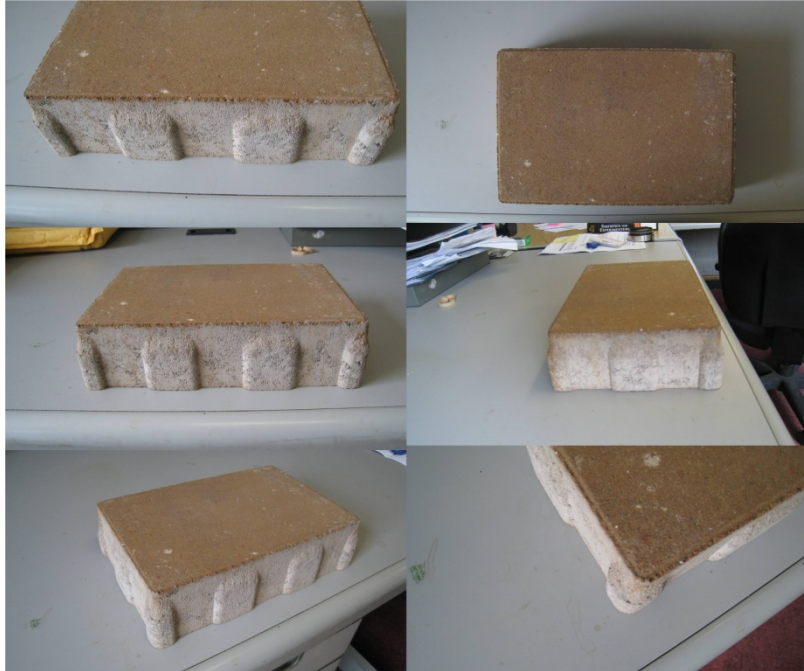
**Figure 26: Eco-Cobble paver block**

Figure 26 shows Eco-Cobble paver block, which provides a 9 mm gap between the pavers using the molded spacer lugs in the structure of the paver. Once arranged in a mat, the spacer lugs of this paver type touch each other and the gaps between the spacer lugs face each other, providing an exact 9 mm gap size.

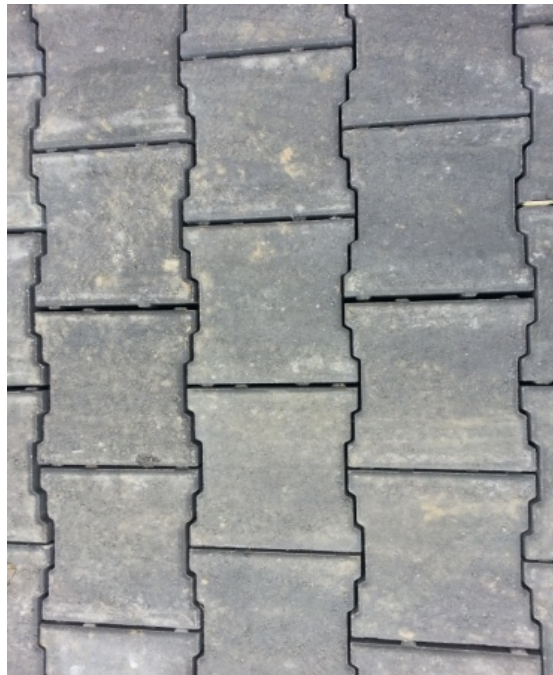
**Figure 28: PaveDrain pavers in Louisville's CSO130 installation**

After consulting with industry experts (Antunes, 2013), it was determined that the running bond was the most commonly used pattern in permeable pavement systems. As an example, the permeable pavement strip on Adams Street in Louisville, KY was arranged with a running bond pattern (Figure 28).; hence this pattern was selected for all

configurations of the experiment. The arrangement of pavers with the selected running bond pattern is shown in Figure 28.

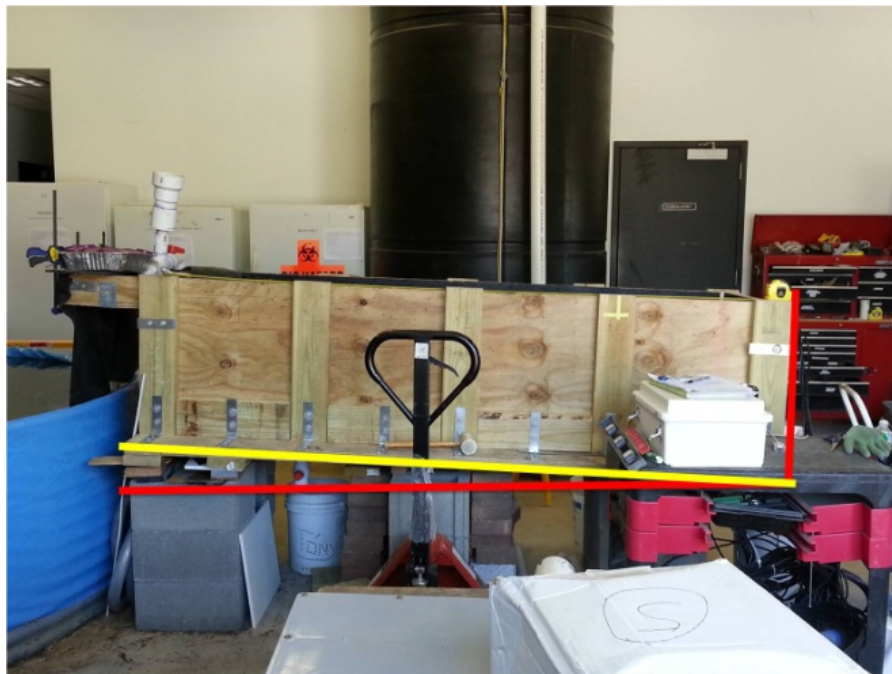
**Figure 30: Illustration of slope of the flume**

In order to investigate the effect of the slopes recommended, the slopes used in this experiment changed from 1% to 3% and then to 5%, the 3 slopes selected for the experiment. The slope is illustrated in Figure 30.

The slope was adjusted by lifting the entire experiment module using a pallet jack, and fitting wooden boards under the up gradient segment of the flume. After each adjustment of the flume, the cross slope was checked at the location of each support.

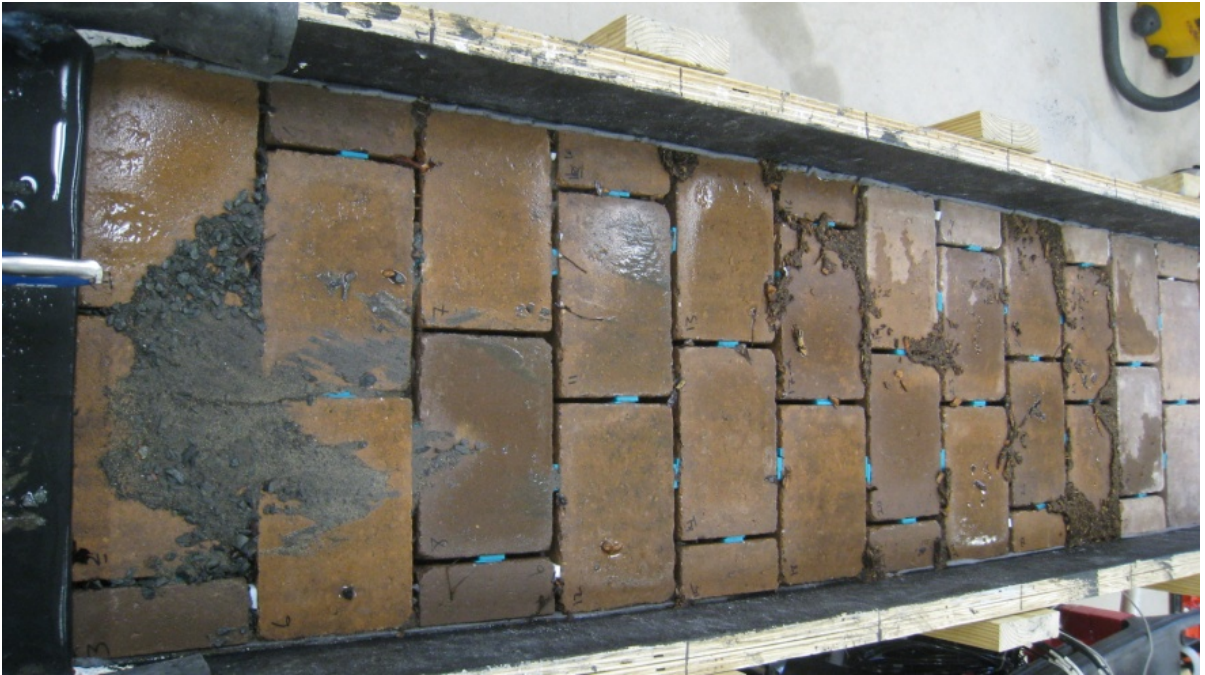
material present, the same pattern was predicted and observed. In these experiments the separation between the organic material and the inorganics was quite obvious. This phenomenon is shown in Figure 32 through Figure 34.

Figure 32: Experiment #1, 1% slope, 6 mm gap size, no aggregate between the pavers

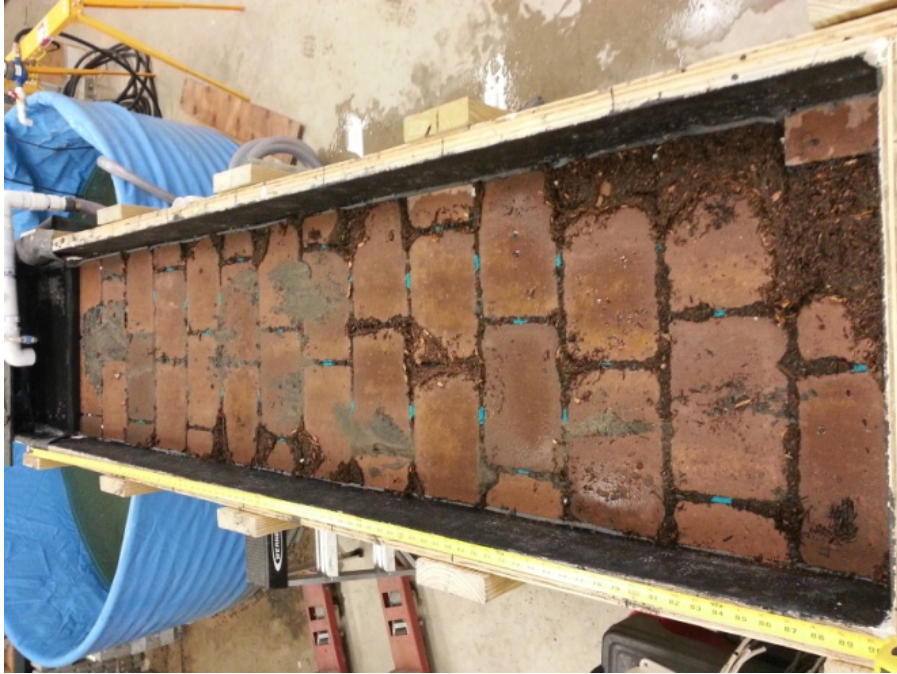
In the experiments where the permeable joint material was present in the gaps, however, a different pattern was observed. In these experiments, and depending on the length of the progression of clogging, both the organic and the inorganic sediment reached the down gradient segments of the flume. In these cases, there was little or no separation between the places where the different kinds of sediment were being deposited. Figure 35 through Figure 37 show the pavers of three different gas sizes, all set at a 1% longitudinal slope, and after the 100-minute period of the experiment.

Figure 35: Experiment #4, 1% slope, 6 mm gap size, no aggregate between the pavers

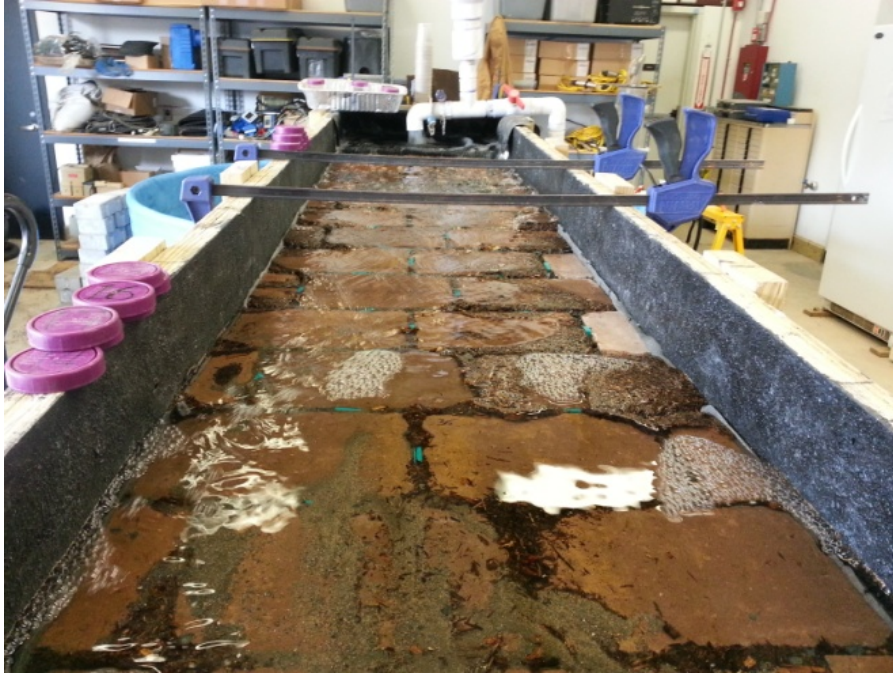
Figure 39: Clogged but not sealed, experiment #14, 3% slope, 6 mm gap size, #8 aggregate between the pavers

The experiments began by starting the runoff flow, and dumping the first sediment cup 30 seconds after beginning the test. As the experiment went on, in almost all the different configurations, it was observed that the speed of clogging decelerated. This was obvious in cases where the steeper longitudinal slope (3% and 5%) and presence of permeable joint material caused the clogging to reach furthest in the down gradient section of the flume. In the tests where this happened, there was no indication of the rapid ponding of water or failure in the flume. Although some ponding was observed, the surface infiltration rate from the clogged pavers was enough to tolerate and infiltrate the runoff flow rate. The condition where the flume's surface is clogged, yet it is still capable of infiltrating some stormwater runoff is referred to as "clogged, but not sealed".

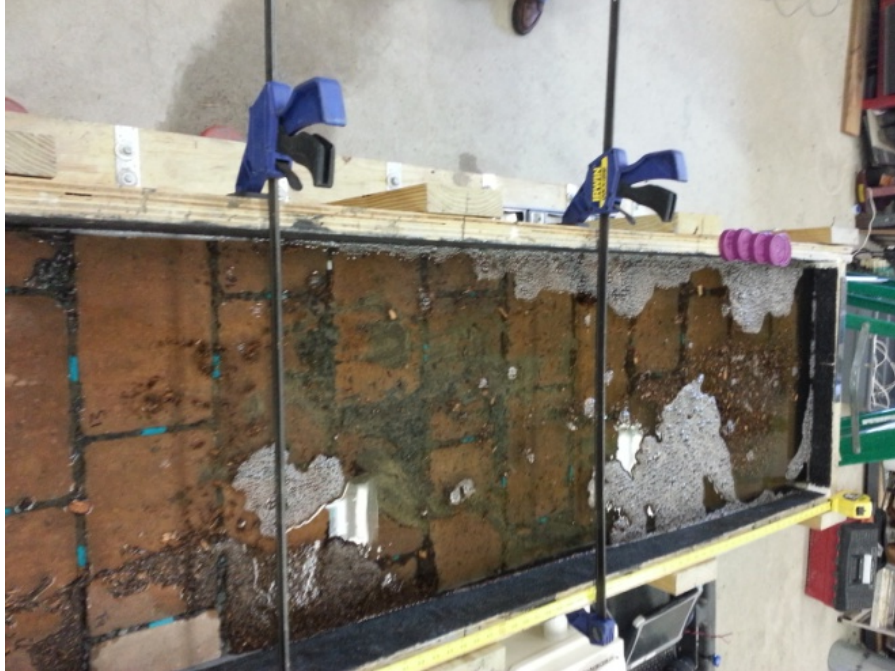
Figure 42: Clogged but not sealed, experiment #20, 5% slope, 6 mm gap size, #8 aggregate between the pavers

Although in all instances, the system was clogged but not sealed, with the observations and measurements made on the depth of ponding at the furthest down gradient segment of the flume, it was observed that with the increase of longitudinal slope and a reduced gap size, the condition of the system would deteriorate very soon. For instance, in experiment #20, with a 5% longitudinal slope, 6 mm gap size, and #8 aggregate as permeable joint material, at the 100-minute mark, half the length of the flume was submerged (Figure 42) and the depth of ponding was about 8 cm (Figure 43).

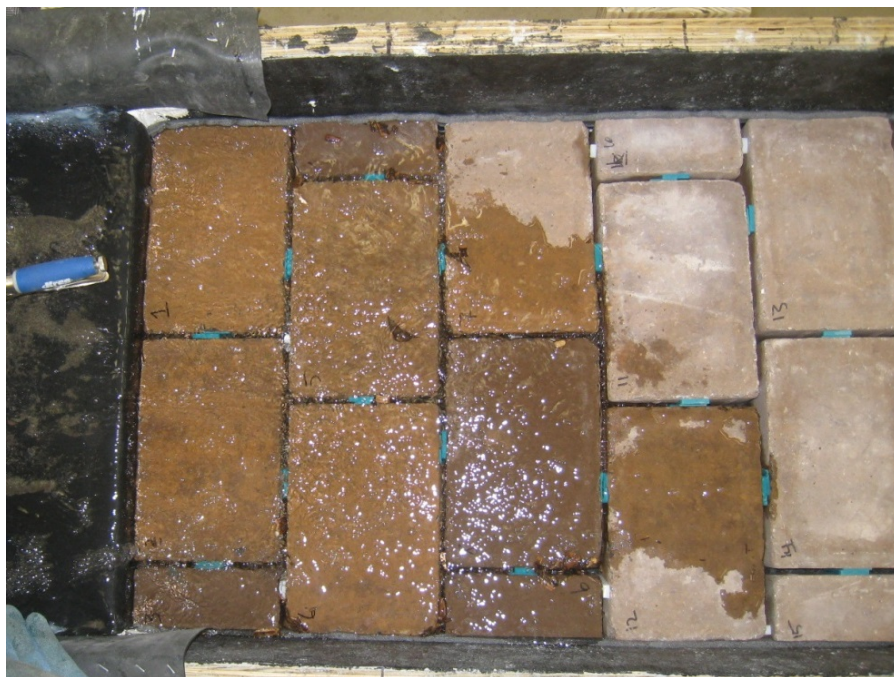
With an increased longitudinal slope, it was observed that the clogging was progressing much faster and in cases where the paver gap sizes were 6 mm and 9 mm and the gaps were filled with permeable joint material, in particular at a 3% and 5% longitudinal slope, the length of clogging in the flume reached the furthest down gradient segment after about a quarter of the sediment cups. Figure 44 shows the start of the experiment after 4 cups of sediment, which illustrates the clogged gaps, while Figure 45, in a photograph taken after 3 cups of sediment, shows that, compared to the previous figure, the progression of clogging reached further down. It also illustrates that the gaps are not completely clogged, for obvious void space is still available. The extent of this behavior is more significant in the experiments where the permeable joint material is present.

Figure 44: Experiment #1, 1% slope, 6 mm gap size, no aggregate between the pavers

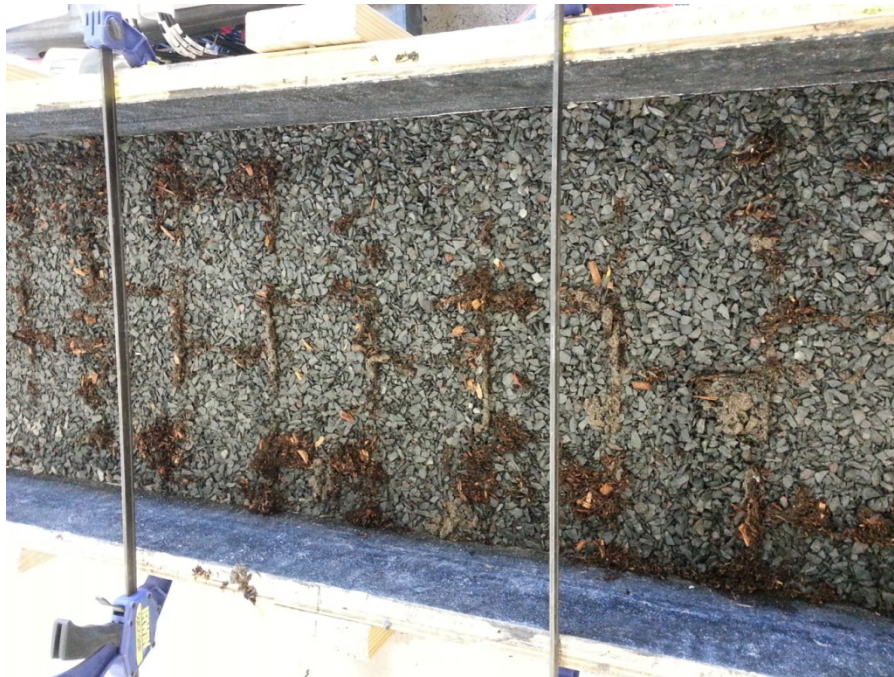
**Figure 46: Experiment #19, 5% slope, 6 mm gap size, no aggregate between the pavers, after removing the pavers**

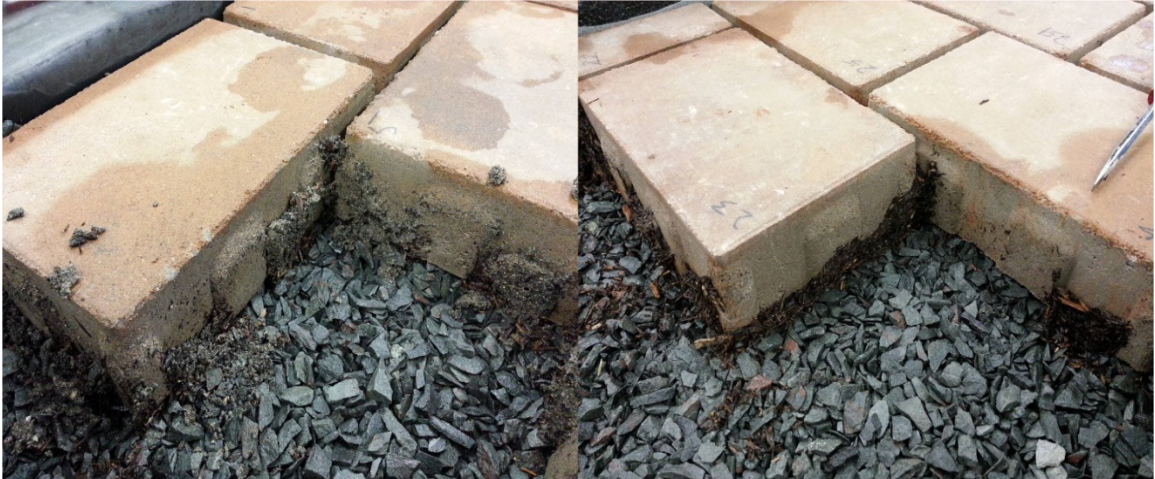
Figure 47: Experiment #11, 3% slope, 9 mm gap size, no aggregate between the pavers, after removing the pavers

When the pavers were removed, there were minimal or no signs of fine particles underneath them and almost all the clogging material was intact (Figure 47), located in the gaps. Figure 46 shows the sediment on the bedding layer after removing the paver from an experiment where no permeable joint material was present. A different pattern was observed in the experiments, where there was #8 in the pavers' gaps. Figure 48 shows the surface of the bedding layer directly after removing the paver blocks. It is obvious that the permeable joint material has reduced the extent of migration of the sediment to the storage gallery.

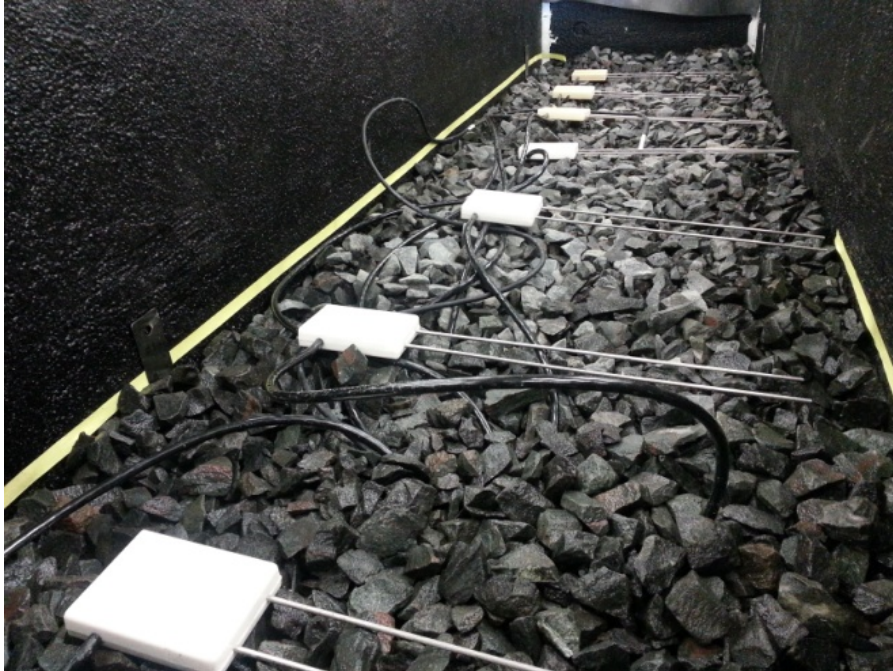
Figure 55: TDRs in the flume

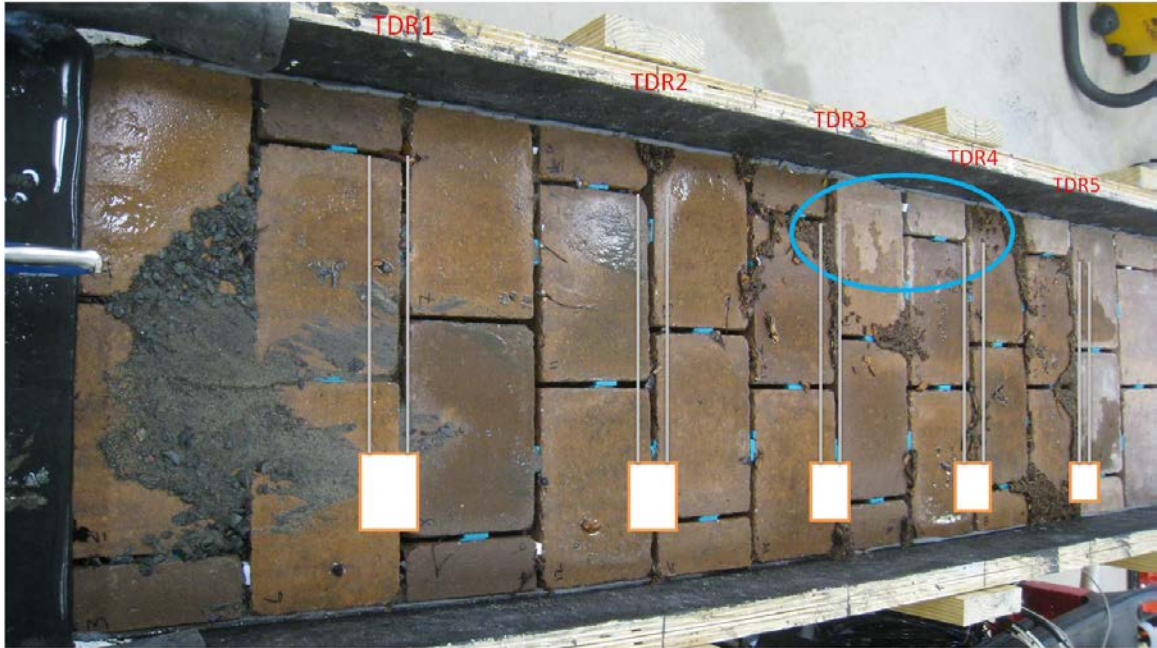
**Figure 62: Flume's overview for progression of clogging in experiment #1**

As the clogging progressed during experiment #1, the blue circle that was over the 4<sup>th</sup> TDR's rods was blocked by mulch deposited on the surface. However, unlike what the numbers might suggest, the clogging had reached this point. After further progress of surface clogging, the dam created by the deposited mulch eventually broke, letting runoff into the gaps. This behavior is a problem of scaling; however, the visual observations during the test can help to eliminate this problem. By excluding the superficial rainfall associated with the time of peak at the location of TDR4, and plotting the trend using the remaining data points, this graph can be plotted correctly. Figure 63 is the corrected plot for the progression of clogging in experiment #1.

In some of the experiments, a TDR located at a location further down the gradient peaks before a TDR located at a location on an up gradient. As an example of this effect, illustrated in Figure 61, surface clogging has progressed as expected from TDR1 to TDR3; however, the further down gradient TDR5, which is located at 142.88 cm, has reached its maximum measurement before TDR4 at 114.3 cm. In other words, the graph suggests that the clogging has moved backwards at some point in the test. In fact, however, based on the visual observation made during the test, the clogging did not move backwards. Figure 62 is an image of the flume after the first experiment, which shows what happened.

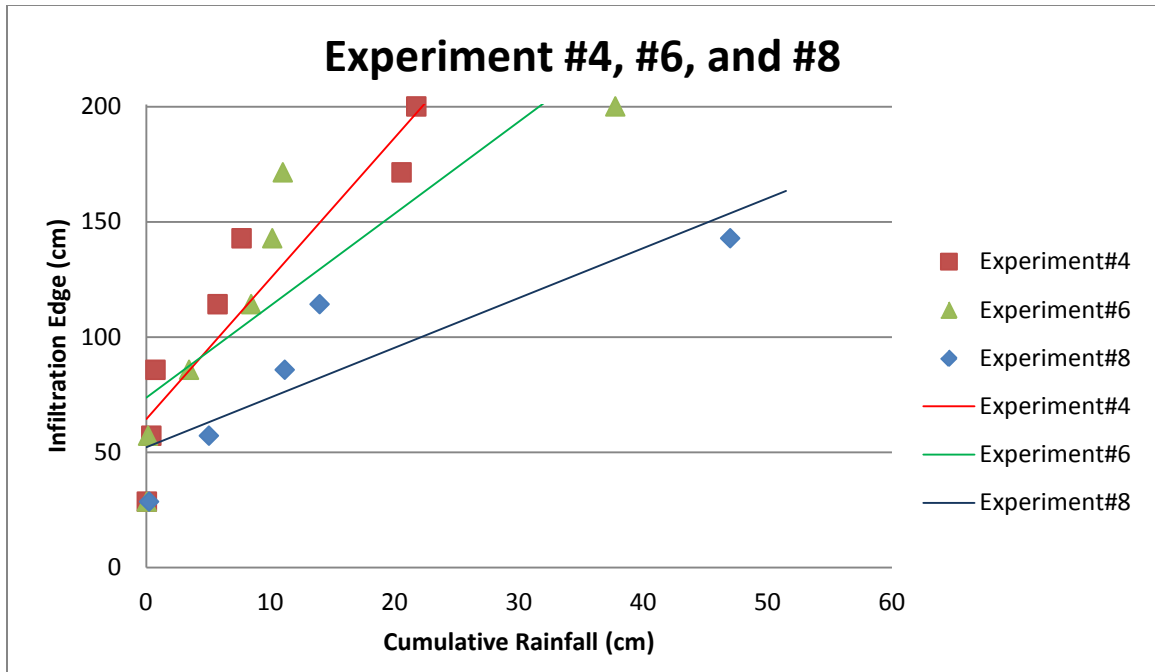
With a 3 mm increase in the gap sizes (experiments #4 and #6), a 1% longitudinal slope, and with permeable joint material, the slope of the progression of clogging increases, meaning that the surface clogging progresses faster. With a further increase in the gap size, the slope of the progression of clogging decreases and is lower than both the previous gaps, meaning that the deterioration of the performance of the permeable surface is the slowest of the three. These patterns are illustrated in Figure 72.

Figure 73: Comparison of progression of infiltration edge in experiments #4, #6, and #8

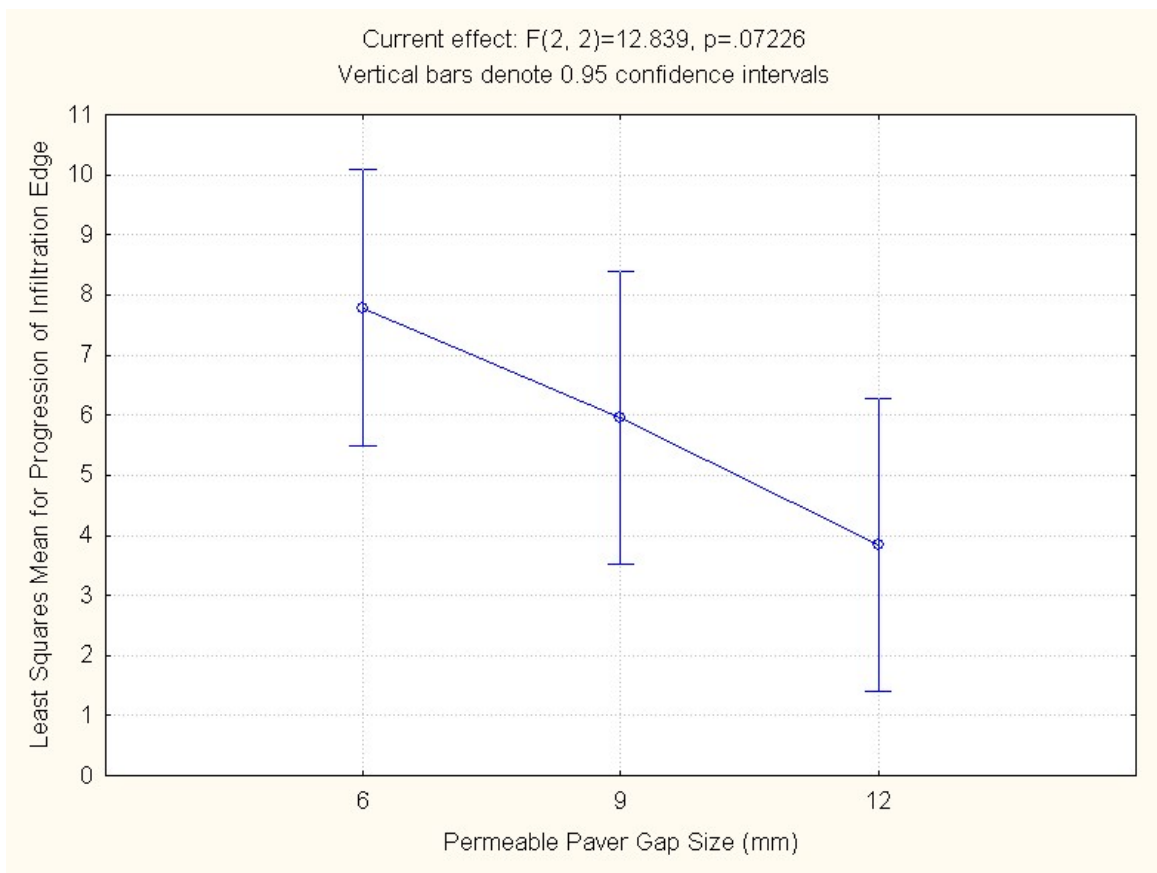
**Figure 116: Analysis of variance of paver gap size for progression of infiltration edge**
