Do rope and washer pumps provide safe water and satisfied users? A case study piloting new rural water supply technology in Rumphi District, Malawi

ABSTRACT

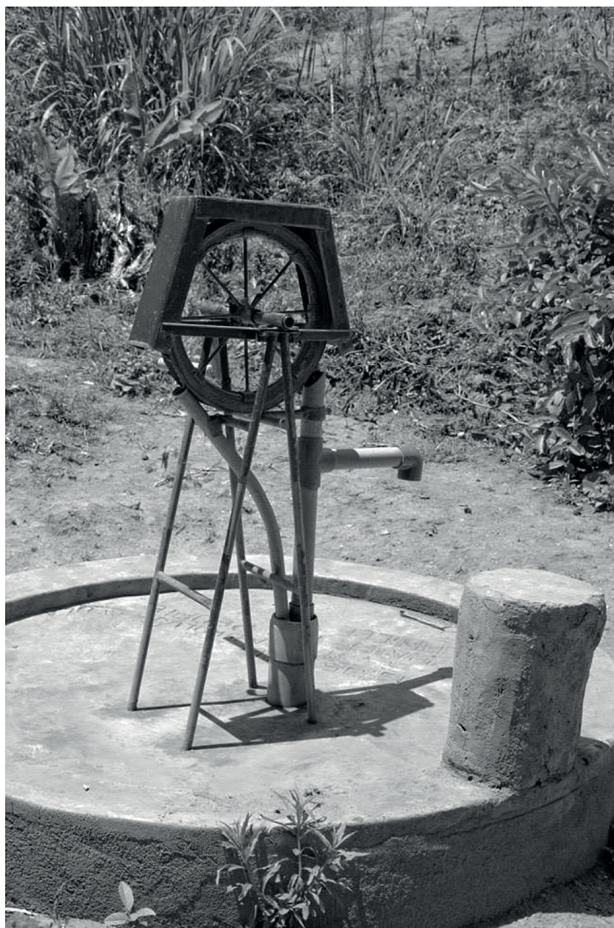
Figure 1. Rope and washer pump, Rumph District

Recently, rope and washer pumps have been the subject of a relatively small number of studies (Fig. 1) in sub-Saharan Africa (Harvey and Drouin, 2006; Coloru et al., 2012; Butterworth et al., 2013; Holm et al., 2017). Water and public health professionals are trying to understand and manage the rural water supply for drinking water with new approaches
