Practical Paper

Can a precast pit latrine concrete floor withstand emptying operations? An investigation from Malawi

Joshua Mchenga and Rochelle H. Holm

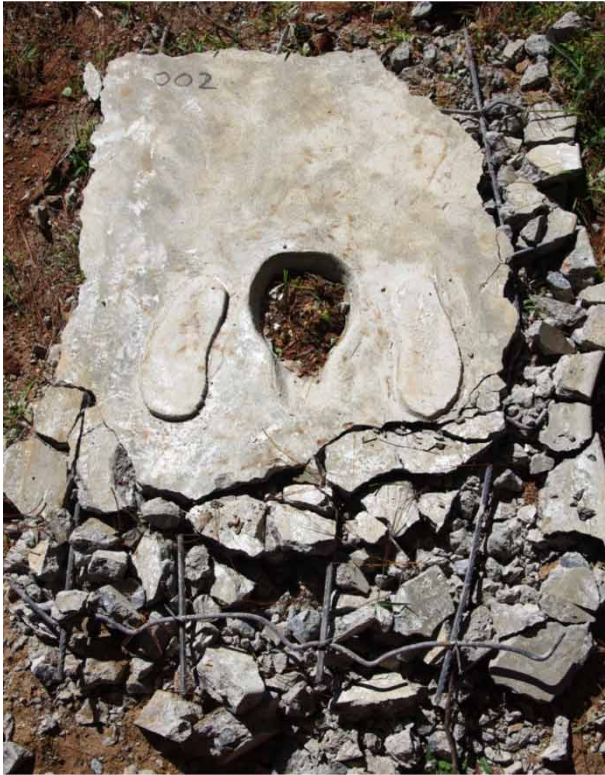
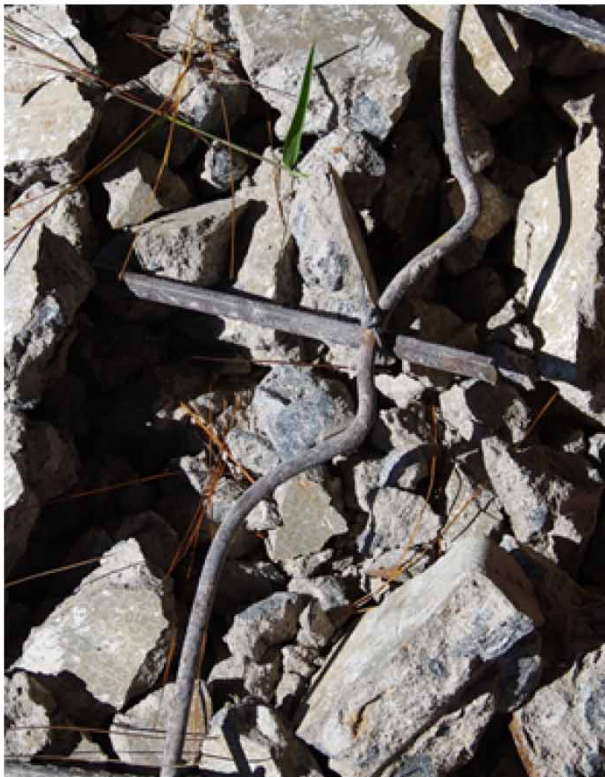
Figure 1 | Precast pit latrine flat slab. Top: reinforcement bar verification exercise. Bottom: reinforcement bar using recycled material.

For each of the dome slabs (3/3), the material (binding wire) reported by the seller was observed to be accurate during the reinforcement verification exercise. However, the dome slab, if constructed properly, does not require any reinforcement, and the cost of dome slab construction could be reduced and the seller profit possibly increased if such reinforcement is not used.

While all of the flat slabs (25/25) had some form of reinforcement, it was observed to be of variable material, size, and spacing (Table 1). Notably, instead of steel reinforcing bars, four slabs had used scrap metal (such as reusing a window frame of a car and a sofa spring), and some of this scrap material was observed to be corroded (Figure 1). Two other flat slabs only used binding wire for reinforcement. In one case, the slab mostly had the proper size of reinforcement, but one length of reinforcement was substituted with a sofa spring. None of the flat slabs met the reinforcement recommended by Harvey (2007).
